No. 2740_BML

- Test object: **SUNKON Connector BP3 (105008001) (more details on page 9)**
Manufacturer SUNKON
- Applicant: SUNKON GmbH
Dühlfeld 26
31553 Sachsenhagen
Germany
- Type of testing:
➤ Test of the lightning impulse current carrying capability of the test classification N (50 kA 10/350) following the principles of DIN EN IEC 62561-1:2024-05
- Conditioning and aging; Section 6.5
 - Electrical testing; Section 6.6
 - Contact resistance; Section 6.6.2 a)
 - Visual inspection; Section 6.6.2 b)
 - Loosening Torque; Section 6.6.2 d)
- Test result:
➤ **The SUNKON Connector BP3 passed the criteria of test class N of DIN EN IEC 62561-1:2024-05 Chapter 6.6.2 a)/b)/d).**
- **Detailed results on page 12.**
- Contents: 24 pages test report including 19 figures and 3 oscillograms.

Description of the test objects: Profile connector for the PV mounting system
SUNKON BP3

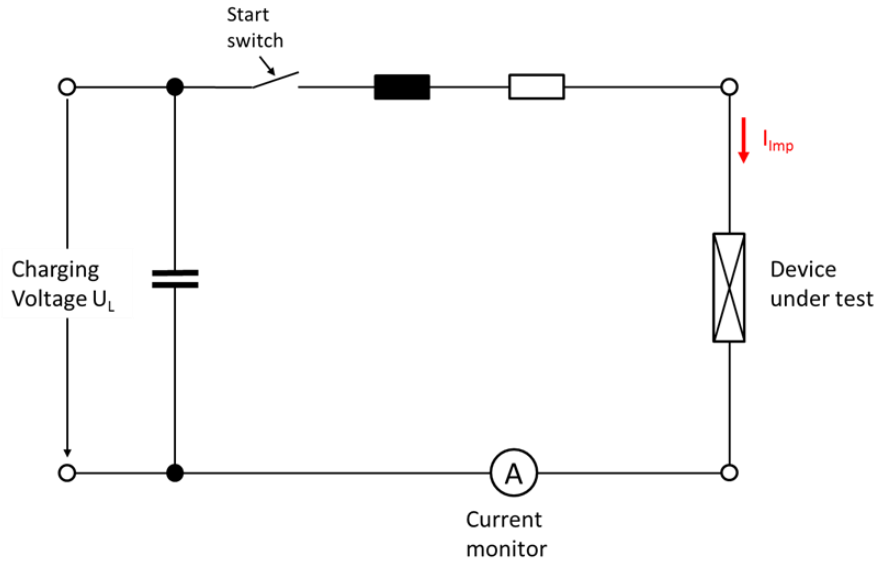
Figure 1: Simplified circuit diagram of the test set-up.

- Figure 1 shows the simplified schematic diagram of the test setup.
- Figure 2 shows the test sample with component designations.
- The test samples were subjected to artificial ageing before the electrical test (see test specifications and Figures 3 to 8).
- The figures 9 and 10 show the test setup with the 50 kA 10/350 µs impulse generator.
- The figures 11 to 16 show the test samples before and after the tests.
- Figure 17 shows the measurement of the temperature.
- Figure 18 shows the measurement of the contact resistance.
- Figure 19 shows the measurement of the torque.

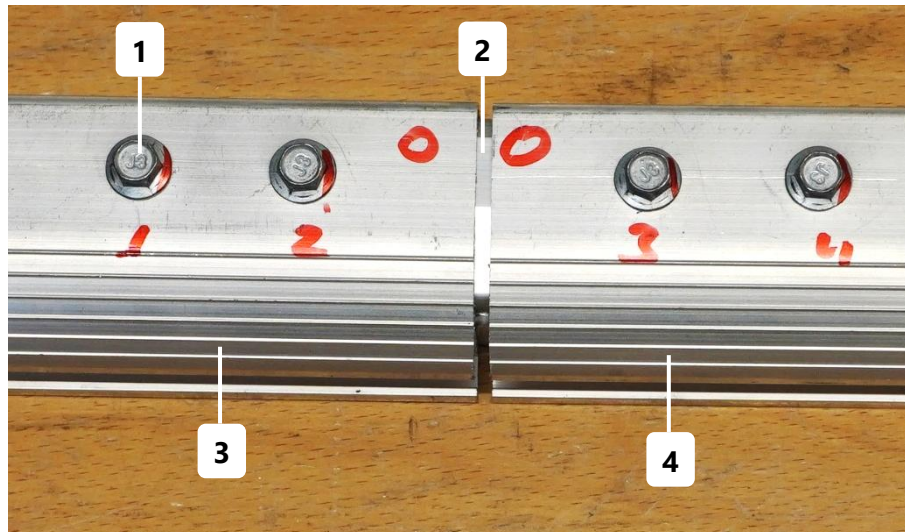
Connection 1:		SUNKON Connector BP3 (105008001)	Pos. in Figure 2
Components	4 x Self-tapping screw 6 x 25 1 x Connector BP3 (105008001)		1 2
Conductor 1:	Profile BP3-3610 (105007002/exemplary BP3 section) material: aluminium		3
Conductor 2:	Profile BP3-3610 (105007002/exemplary BP3 section) material: aluminium		4

Figure 2: Connection 1 with component designations.

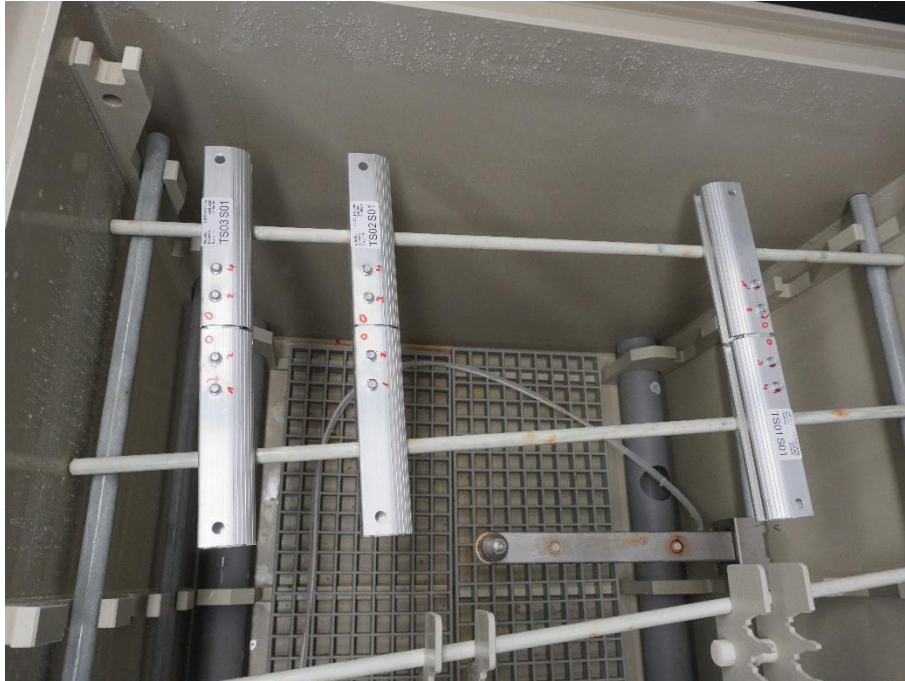
Figure 3: Test sample in the salt mist treatment device.

- Chapter 4.2 → Chapter 6.5 – Conditioning/ageing of the test samples for general use:
Annex D.2 – Salt mist treatment in accordance with IEC 60068-2-52:2017, except clause 7, 10 and 11 which are not applicable → 3 cycles: 2 h spraying at 35° C with salt solution followed by 22 h recovery at 40 °C.
Annex D.3 – Treatment with humid sulphurous atmosphere in accordance with ISO 22479:2019 Method B with a sulphur dioxide volume concentration of 667×10^{-6} → 7 cycles: 8 h heating time at 40 °C in humid atmosphere followed by 16 h recovery.

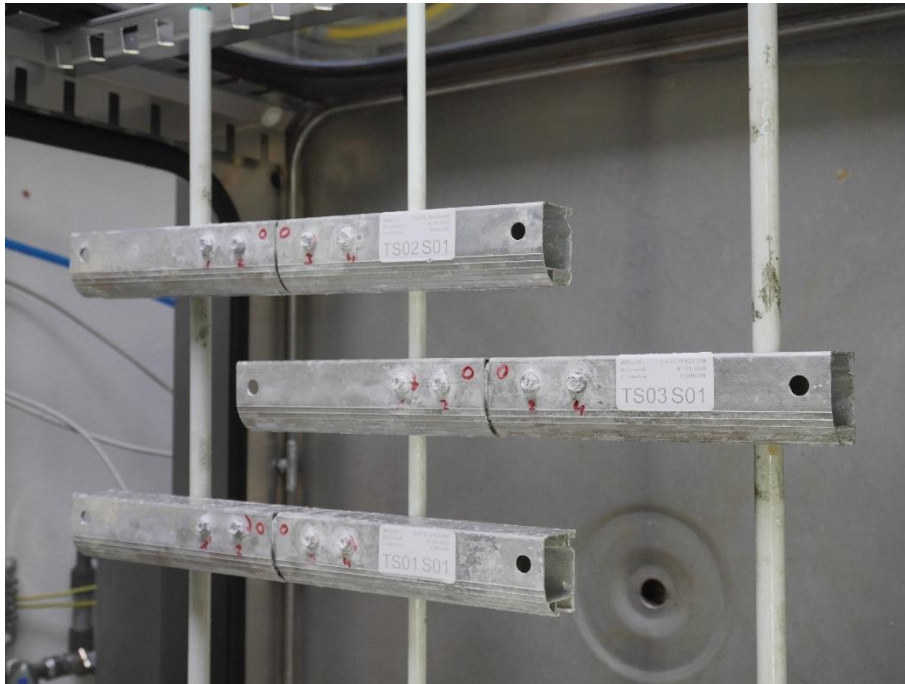
Figure 5: Test samples in the humid sulphurous atmosphere device.

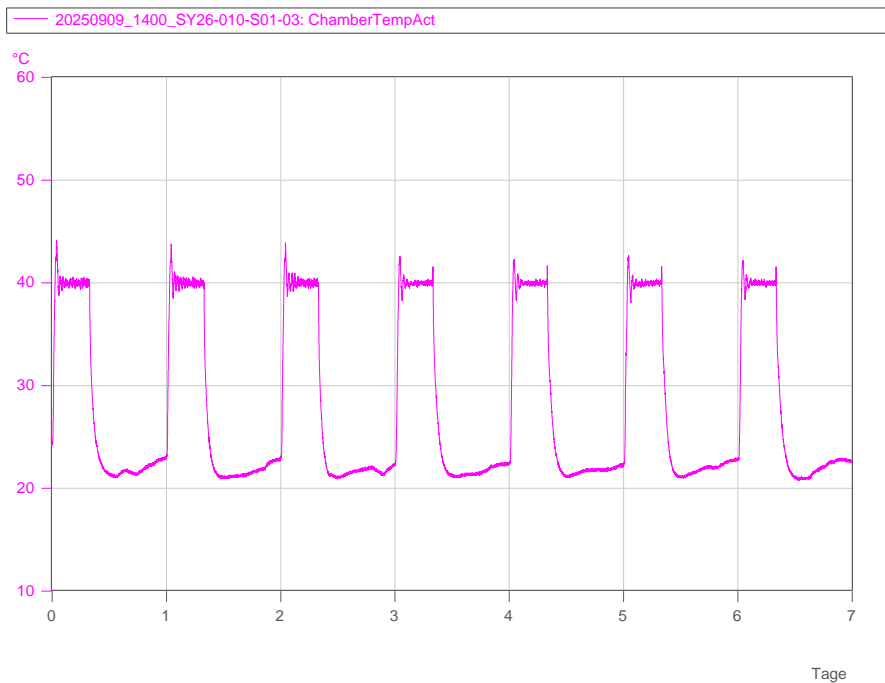
Figure 6: Temperature diagram of the humid sulphurous atmosphere treatment.

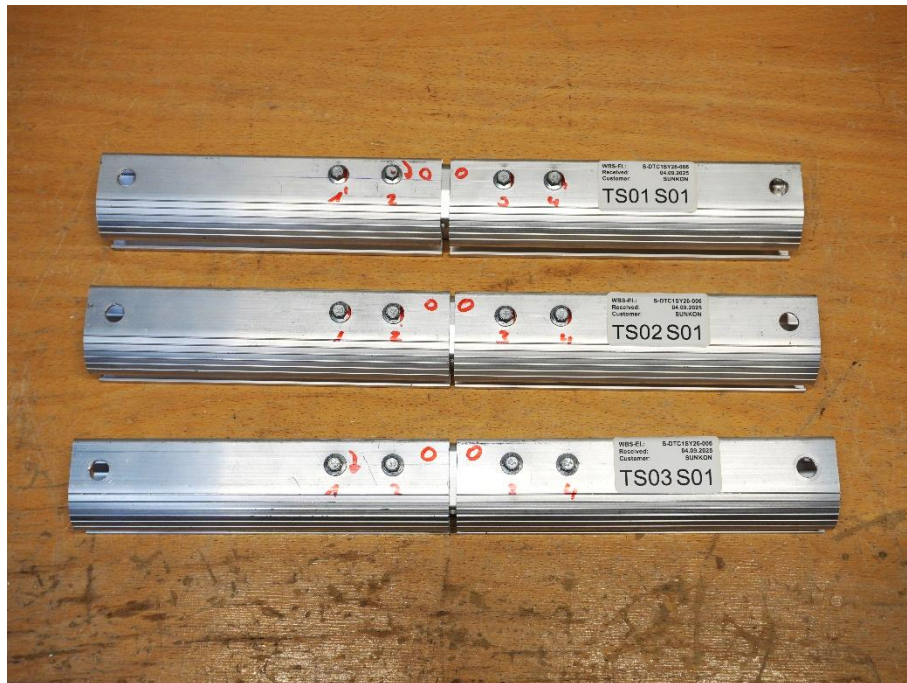
Figure 7: Test samples before the conditioning/ageing process.

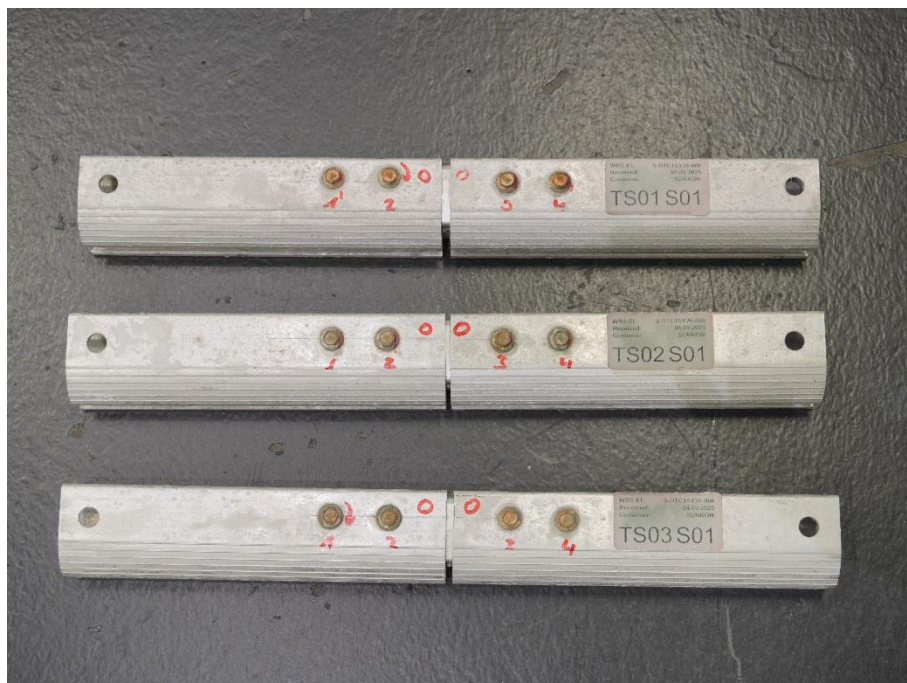
Figure 8: Test samples after the conditioning/ageing process.

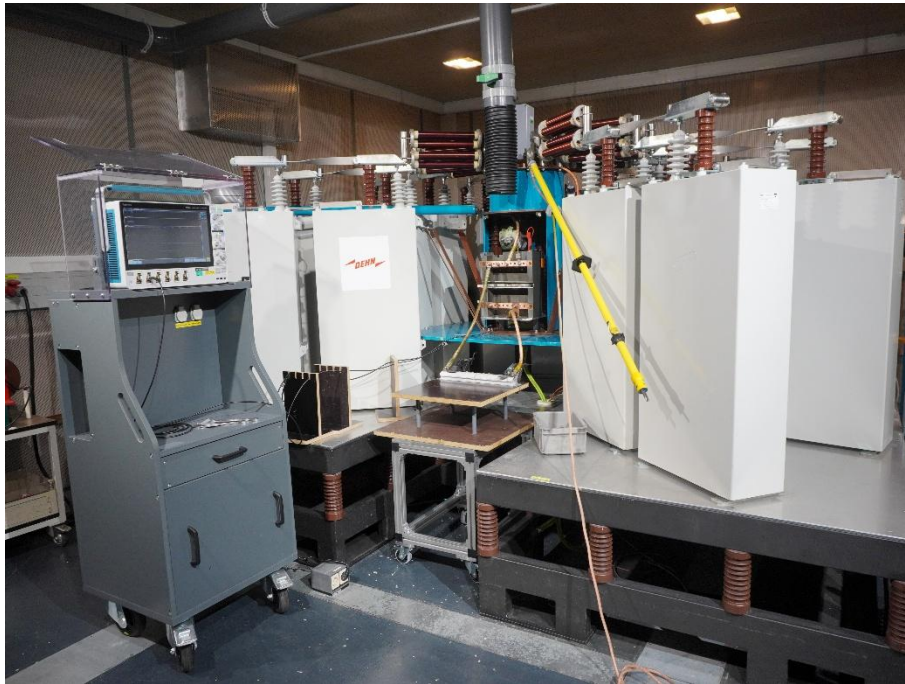
Figure 9: Electrical test – Overall view of the test set-up in the 50 kA (10/350 μ s) Impulse Current Generator.

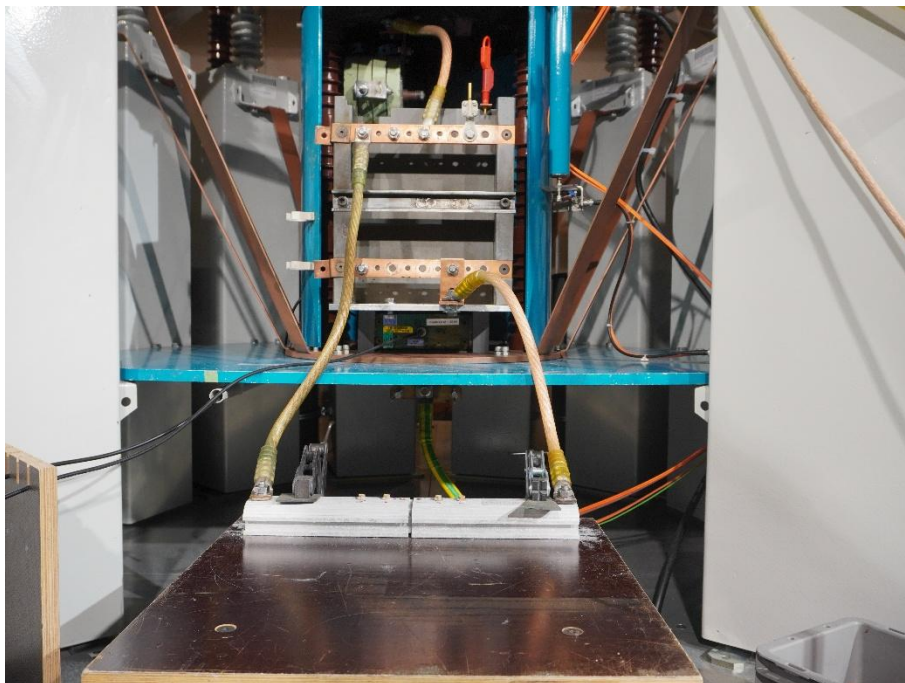
Figure 10: Connection of the generator and the grounded cable.

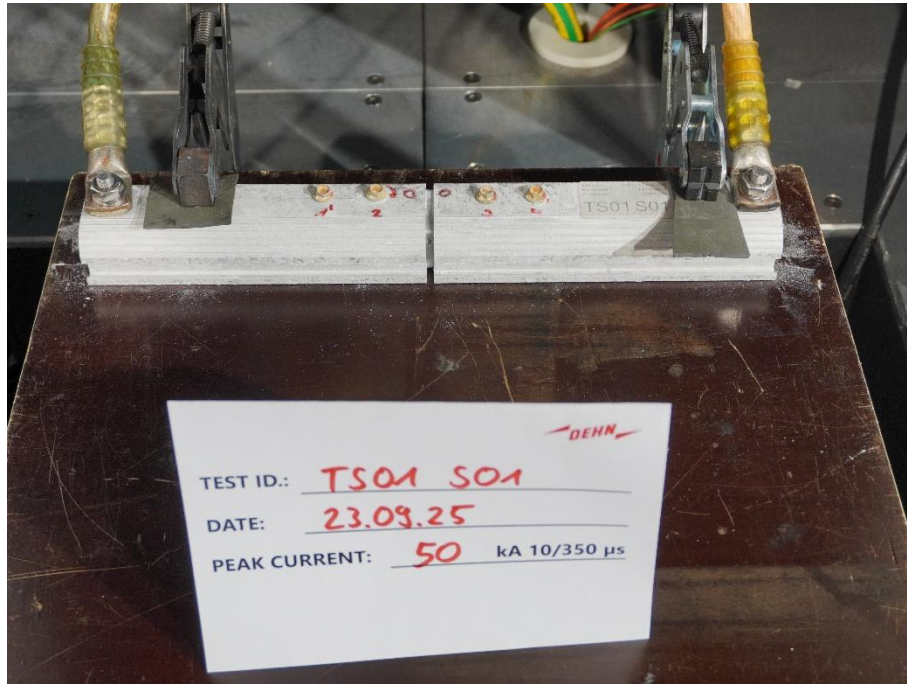
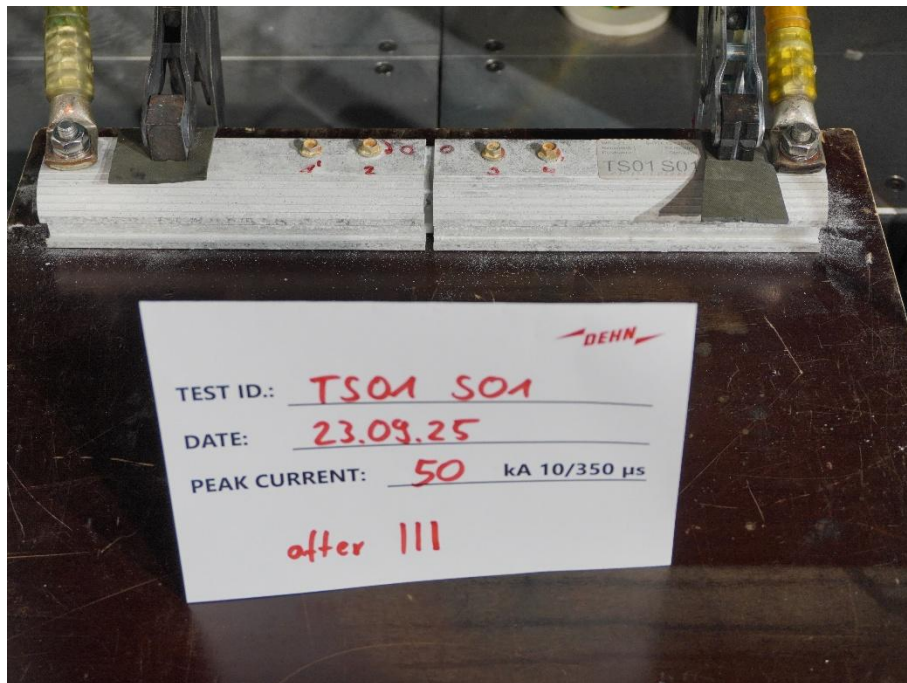
Figure 11: Test sample TS01 S01 before test with 3x 50 kA (10/350 μ s).

Figure 12: Test sample TS01 S01 after test with 3x 50 kA (10/350 μ s).

- The figures 11 and 12 show the test sample before and after the test with 3x 50 kA (10/350 µs).
- After the electrical test, no loose parts or deformation are visible, which would impairing its normal use.
- The contact resistances R_c after the last impulse current were $\leq 3 \text{ m}\Omega$.
- The loosening torque of the screw-connections is greater than 0,25 times and less than 1,5 times of the tightening torque.

The test object **passed** the criteria based on DIN EN IEC 62561-1 chapter 6.6, Class N with 3x 50 kA (10/350 µs) and chapter 6.6.2 a)/b)/d).

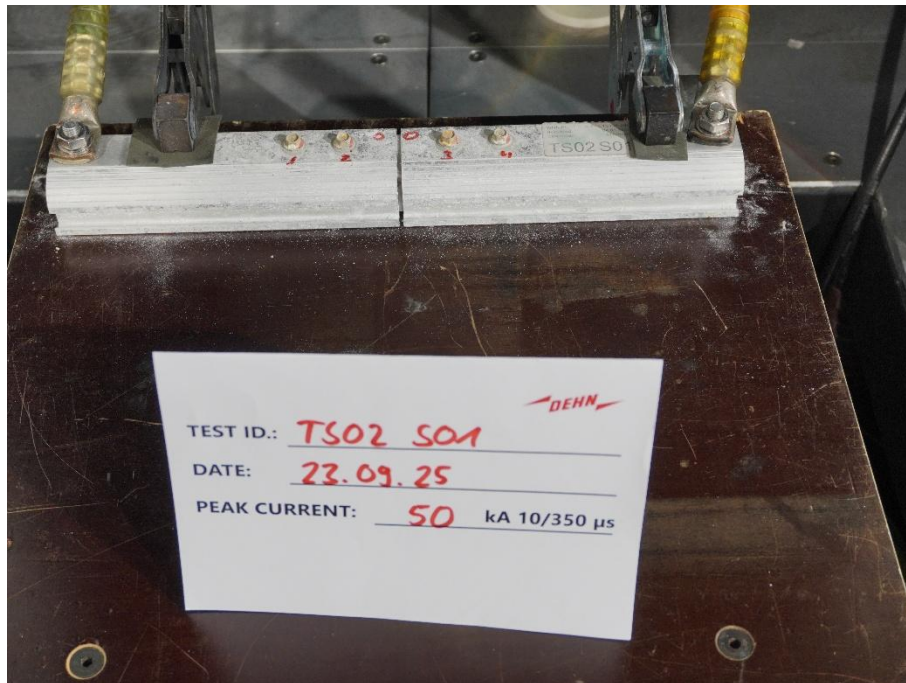
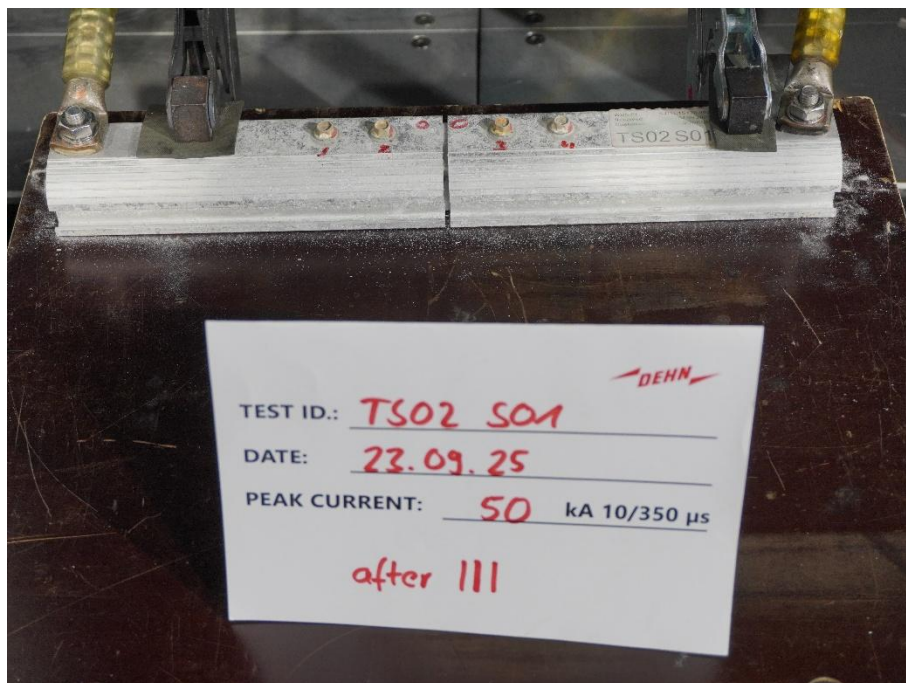
Figure 13: Test sample TS02 S01 before test with 3x 50 kA (10/350 μ s).

Figure 14: Test sample TS02 S01 after test with 3x 50 kA (10/350 μ s).

- The figures 13 and 14 show the test sample before and after the test with 3x 50 kA (10/350 µs).
- After the electrical test, no loose parts or deformation are visible, which would impairing its normal use.
- The contact resistances R_c after the last impulse current were $\leq 3 \text{ m}\Omega$.
- The loosening torque of the screw-connections is greater than 0,25 times and less than 1,5 times of the tightening torque.

The test object **passed** the criteria based on DIN EN IEC 62561-1 chapter 6.6, Class N with 3x 50 kA (10/350 µs) and chapter 6.6.2 a)/b)/d).

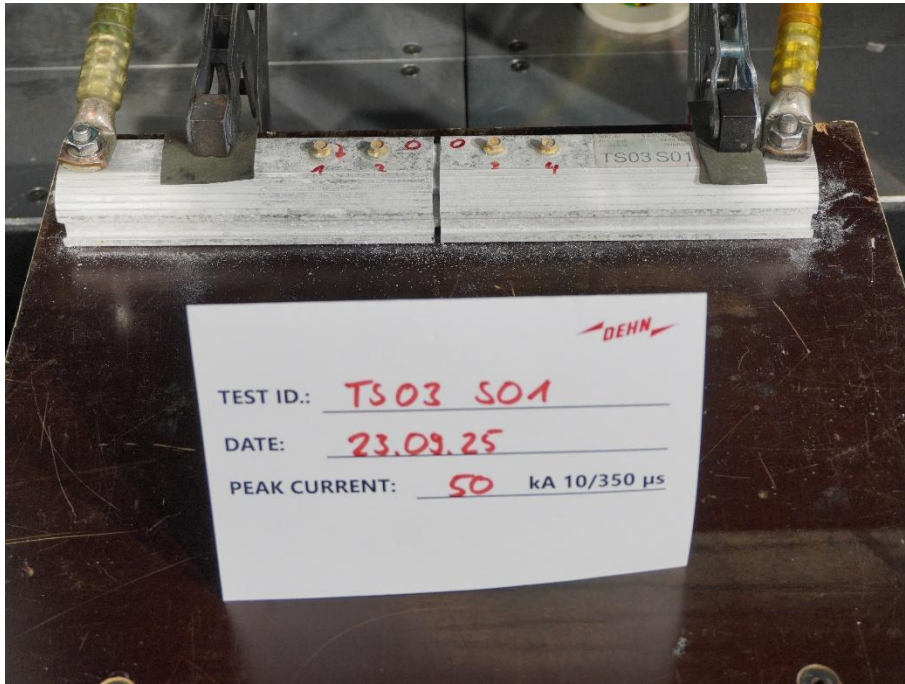
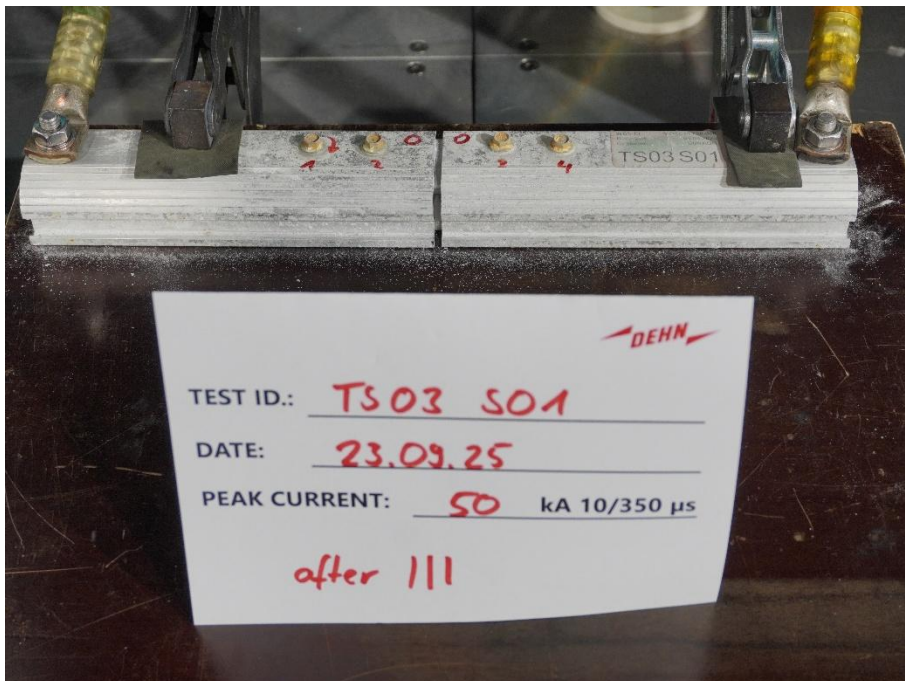
Figure 15: Test sample TS03 S01 before test with 3x 50 kA (10/350 μ s).

Figure 16: Test sample TS03 S01 after test with 3x 50 kA (10/350 μ s).

- The figures 15 and 16 show the test sample before and after the test with 3x 50 kA (10/350 µs).
- After the electrical test, no loose parts or deformation are visible, which would impairing its normal use.
- The contact resistances R_c after the last impulse current were $\leq 3 \text{ m}\Omega$.
- The loosening torque of the screw-connections is greater than 0,25 times and less than 1,5 times of the tightening torque.

The test object **passed** the criteria based on DIN EN IEC 62561-1 chapter 6.6, Class N with 3x 50 kA (10/350 µs) and chapter 6.6.2 a)/b)/d).

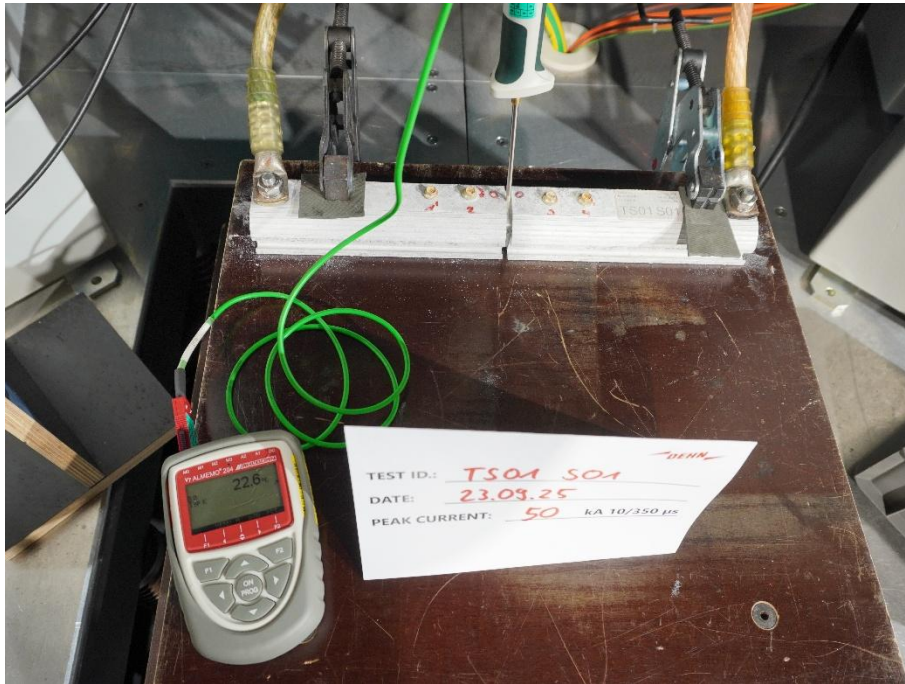
Figure 17: Measurement of test sample temperature.

Test sample	Measurement point/ Connection	before imp. 1	before imp. 2	before imp. 3
		[°C]	[°C]	[°C]
TS01 S01	1	22,5	22,8	22,9
TS02 S01	1	23,1	23,3	23,2
TS03 S01	1	22,9	23,4	23,6

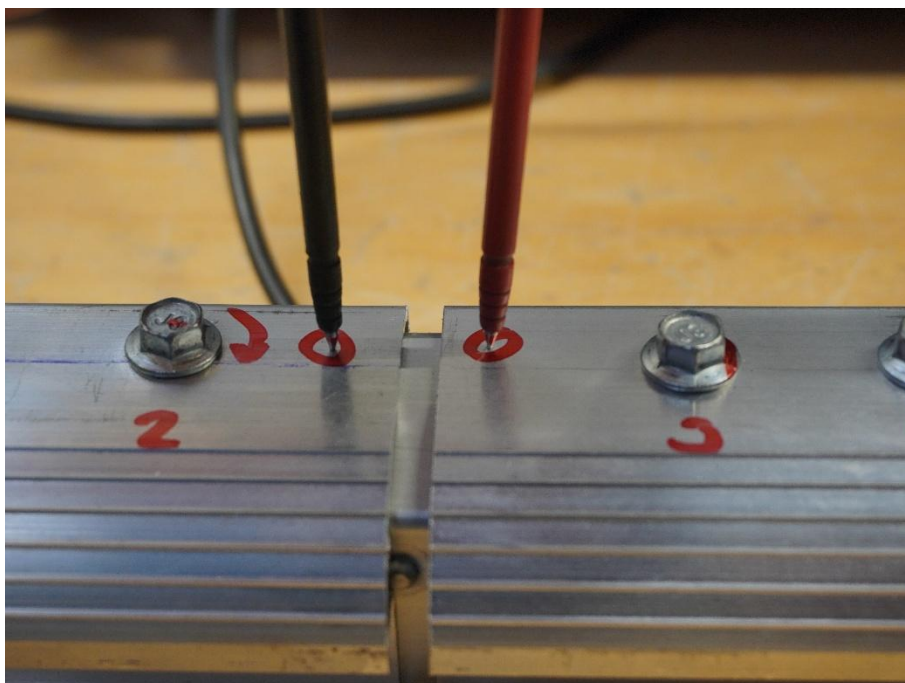
Figure 18: Measurement of contact resistance.

- Chapter 6.6.2 a) – Measurement of the contact resistance with a source of at least 5 A, using voltmeter-ammeter method after the last load. The contact resistance after the last impulse current load must be equal or less than 3 m Ω .

Test sample	Measurement point/ Connection	After assembly R _ü [mΩ] (informative)	After imp. 3 R _ü [mΩ] (≤ 3)
TS01 S01	1	0,016	0,014
TS02 S01	1	0,016	0,015
TS03 S01	1	0,018	0,017

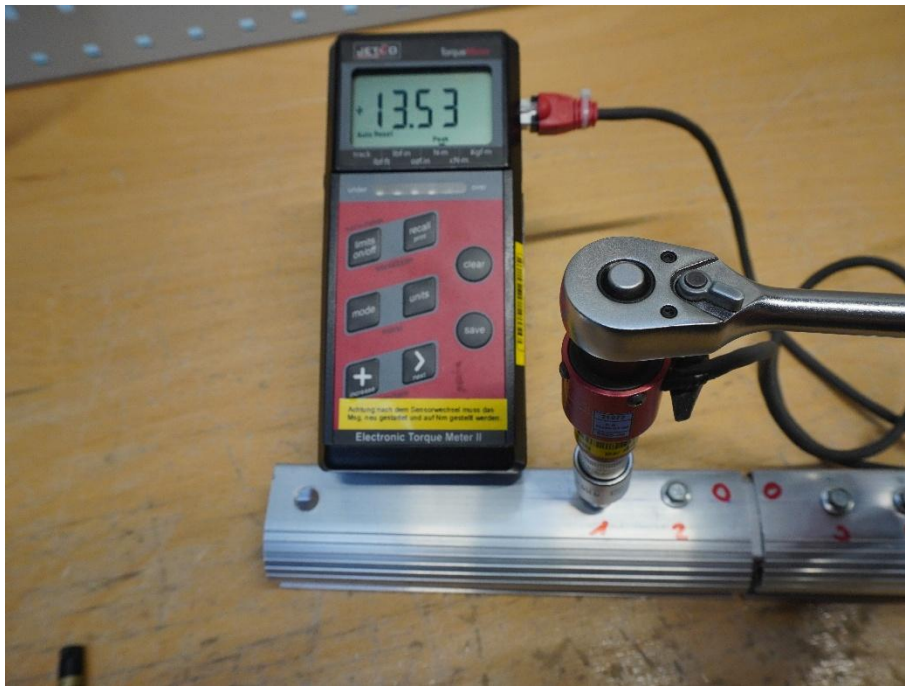
Figure 19: Measurement of torque – exemplary for all screws.

- Chapter 4.4 b) → Chapter 6.6.2 d) – Determination of the loosening torque after the last 10/350 μ s impulse current. The loosening torque must be greater than 0,25 times and less than 1,5 times of the tightening torque.

Test sample	Measurement point	Tightening torque [Nm]	Loosening torque [Nm]
TS01 S01	Screw 1	13,5	9,1
	Screw 2	12,3 ¹⁾	8,2
	Screw 3	13,5	7,3
	Screw 4	13,5	7,3
TS02 S01	Screw 1	13,5	7,8
	Screw 2	13,5	7,7
	Screw 3	13,5	6,8
	Screw 4	13,5	7,4
TS03 S01	Screw 1	12,9 ¹⁾	7,7
	Screw 2	13,5	7,2
	Screw 3	13,5	5,5
	Screw 4	13,5	7,6

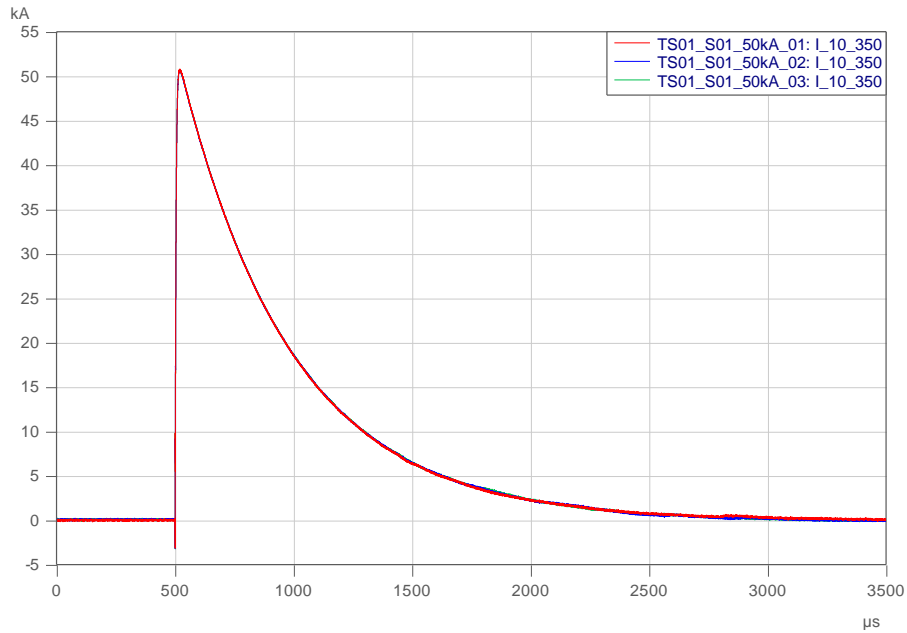
Oscillogram 1: Test sample TS01 S01: 3x 50 kA (10/350 µs).

Test sample	Impulse no.	I _{imp} [kA]	W/R [kJ/Ω]	T ₁ [μs]	T ₂ [μs]	I _{imp} ≤ 50 μs	W/R _{Td} < 5 ms
TS01 S01	1x 50 kA	50,8	658,8	9,8	350,8	OK	OK
	2x 50 kA	50,7	657,2	9,8	351,9	OK	OK
	3x 50 kA	50,8	657,5	10,0	352,0	OK	OK
TS02 S01	1x 50 kA	50,8	658,0	9,9	352,3	OK	OK
	2x 50 kA	50,8	658,3	9,8	352,4	OK	OK
	3x 50 kA	50,8	659,3	9,9	352,8	OK	OK
TS03 S01	1x 50 kA	50,3	648,0	9,9	353,3	OK	OK
	2x 50 kA	50,8	658,8	9,8	352,7	OK	OK
	3x 50 kA	50,8	658,9	9,8	352,1	OK	OK

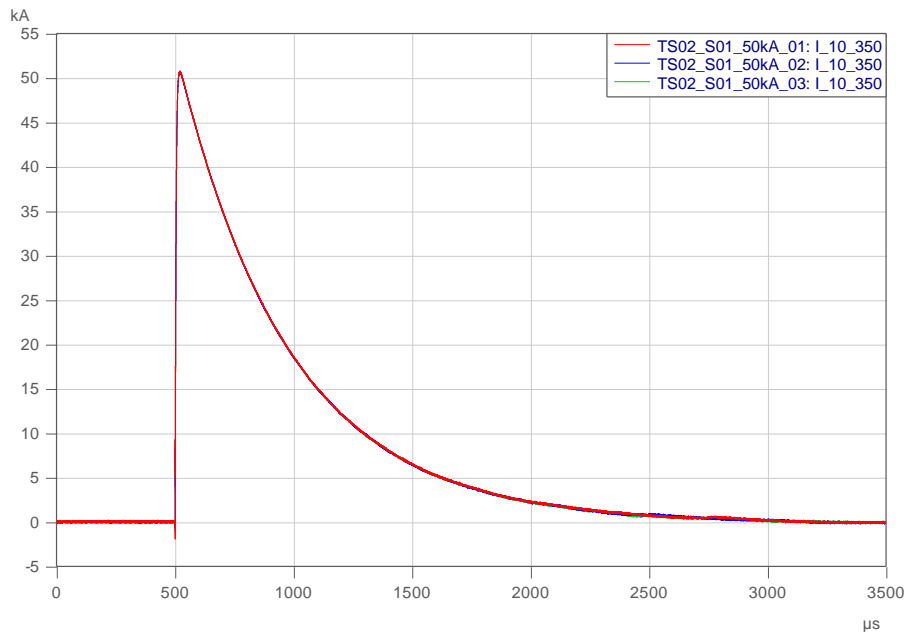
Oscillogram 2: Test sample TS02 S01: 3x 50 kA (10/350 µs).

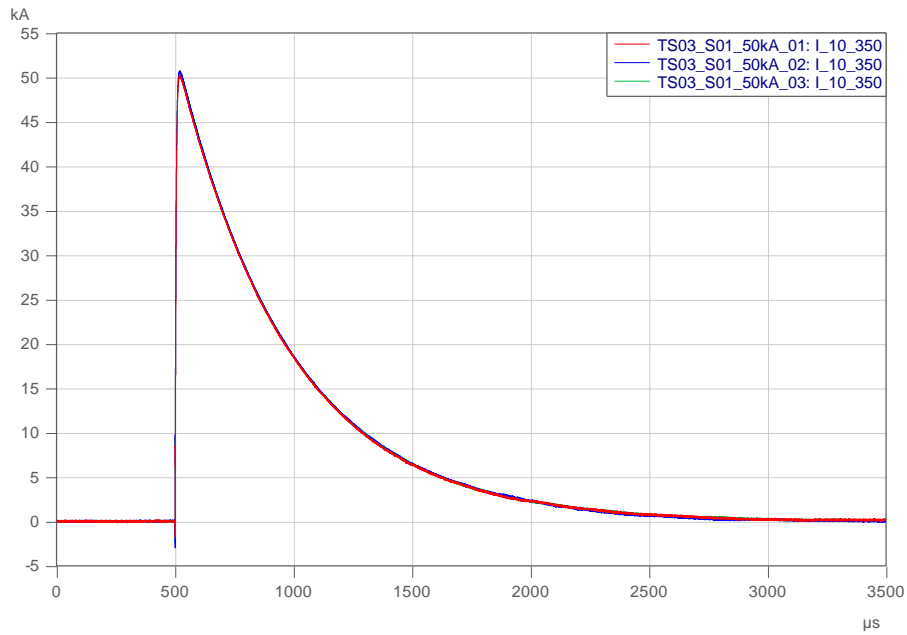
Oscillogram 3: Test sample TS03 S01: 3x 50 kA (10/350 µs).
